# Report on the State of Otty Lake and its Watershed

May 2007

Otty Lake Association and volunteers

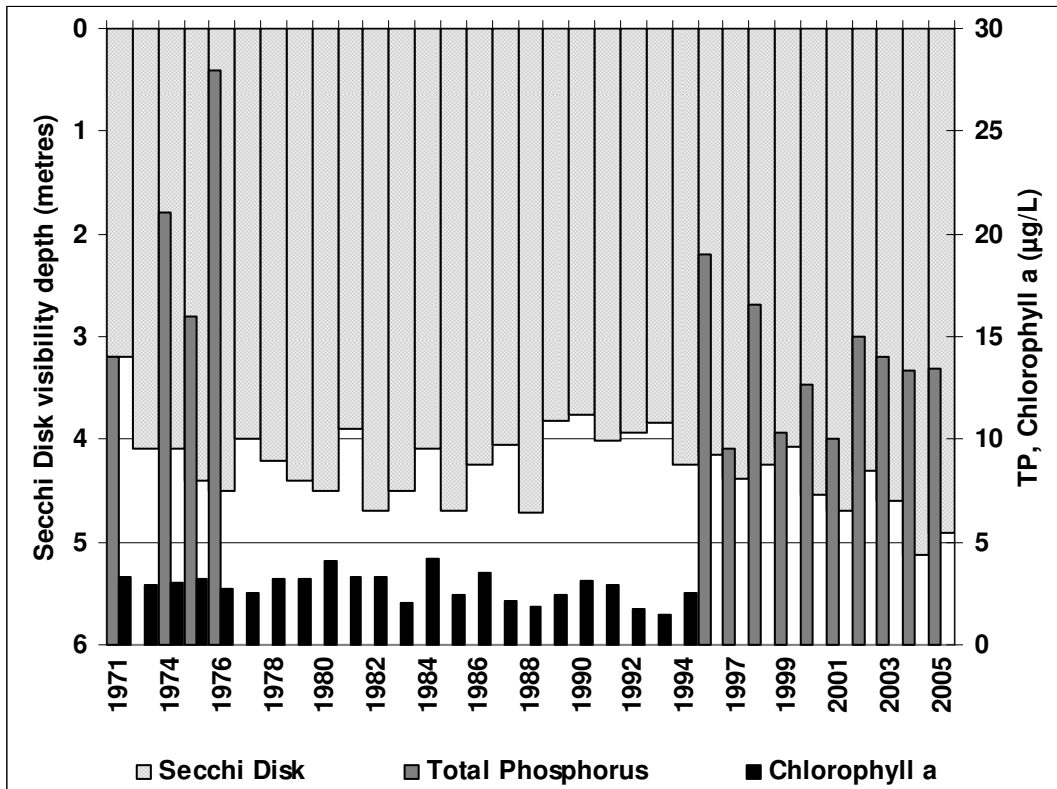
Figure 4: Average annual water clarity (based on secchi disk depth) and nutrient concentration (total phosphorus (TP) and chlorophyll a) across sample sites on Otty Lake between 1971 and 2005.

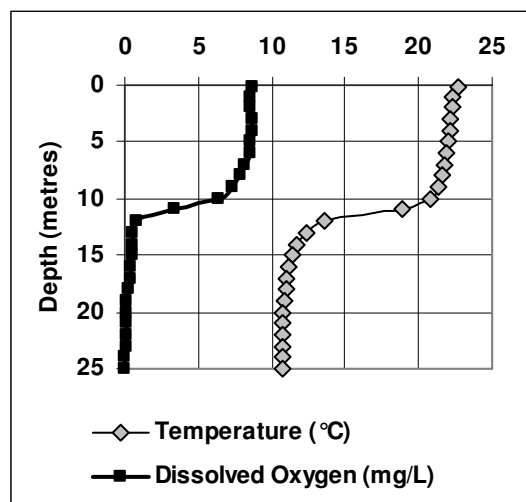
**Figure 5: Temperature and dissolved oxygen profile taken September 9, 2002**

Dissolved oxygen and temperature profiling is important because both factors affect the chemistry of the lake environment as well as the aquatic organisms. A dissolved oxygen and temperature profile was done at the mid-lake site in early September 2002 when the oxygen concentrations would have been at or near the lowest for the year and temperatures the warmest. The profile showed there was ample depth suitable for a cool water fishery above the thermocline however the portion of lake depth below the thermocline (**hypolimnion**) was **anoxic** meaning it held almost no oxygen (Figure 5). The 2002 profile was virtually identical to another profile done in September 1974 suggesting that the anoxic condition

below 12 m (39 ft) may be typical for Otty Lake.

Anoxic conditions indicate that too much oxygen is being consumed when plant and animal material on the lake bottom decay. As oxygen is used up, phosphorus trapped in the sediment at the bottom of the lake is released and reenters the water column. Depending on wind and temperature each year, the extra phosphorus in the anoxic zone could become mixed with the surface water and result in algae blooms.

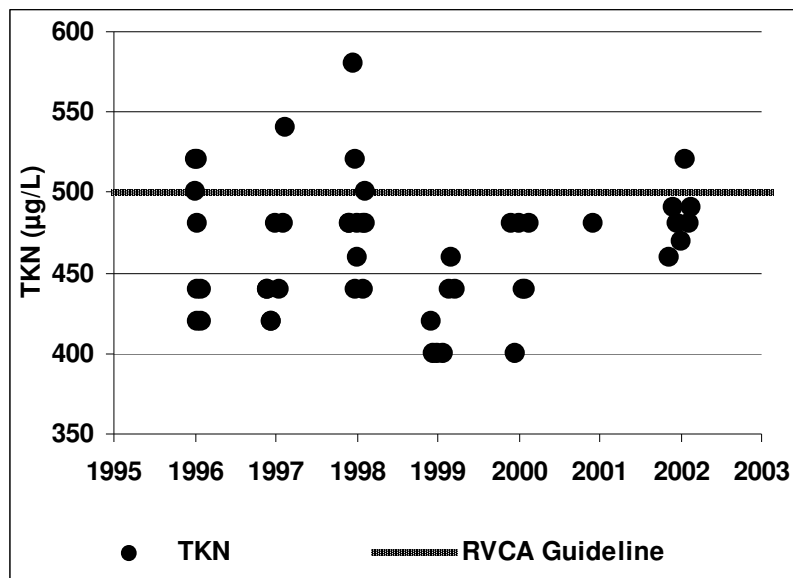
**Figure 6: Individual Total Kjeldahl Nitrogen (TKN) samples collected in spring/summer at the deep site on Otty Lake between 1996 and 2002.**

From 1996 through 2001, 41 samples were taken at the deep point of Otty Lake and analyzed for the concentration of TKN (Figure 6). The average concentration for that period was 461 µg/L and of the 41 sample results, 5 were above the guideline concentration, which is quite good. For the 7 samples taken at the deep point in 2002, the average TKN concentration was 484 µg/L, with one result above the guideline, again quite good. However, while it is sample results from the centre of a lake that are considered to represent the overall “health” of that lake, sources of nitrogen from around the lake contribute to those results. In 2002 a total of 64 additional samples were taken from various other sites around Otty Lake and over half of those (36) had concentrations above 500 µg/L.

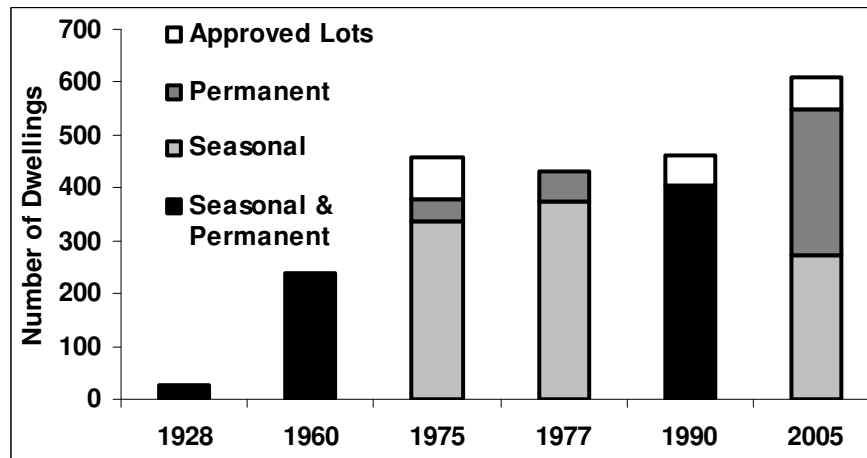
**Figure 9: Development on Otty Lake between 1928 and 2005. The number of seasonal and permanent residences, as well as the number of approved lots, are shown when information was available.**

Between 1960 and 1975, the number of cottages on the lake increased by more than 50%. Just over 10% of the property owners at that time chose to live permanently on the lake (Figure 9).

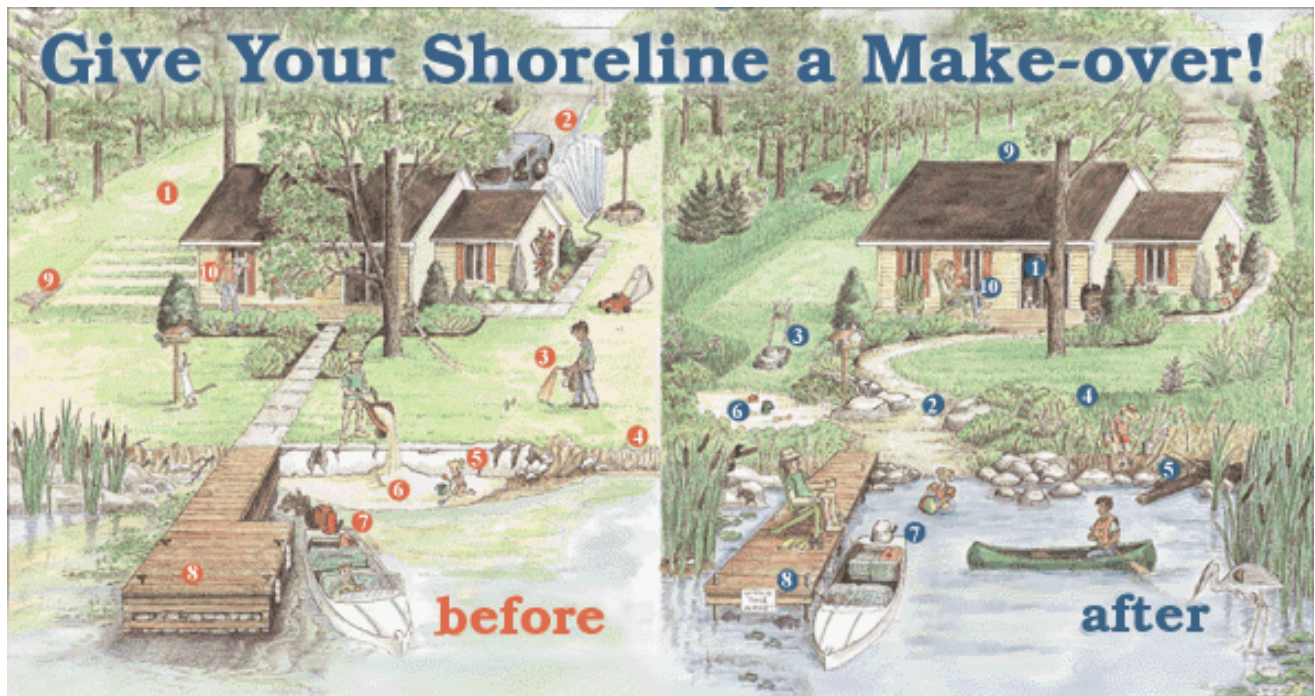
**Figure 11: Illustration from the Living By Water Project<sup>22</sup> showing best management practices on a lakefront property**
