Otty Lake Shoreline Assessment Summary Report

May 2015

Submitted to the Otty Lake Association by Watersheds Canada

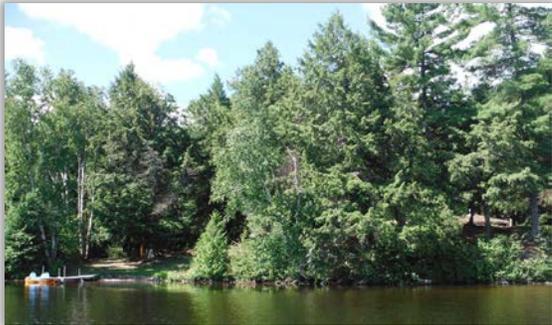
Class & Description	Photograph Example*
<p>Natural – A healthy buffer of vegetation and/or a natural shoreline of sand or exposed rock that is undisturbed and undeveloped.</p>

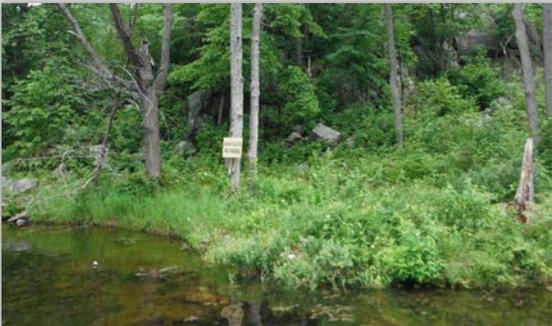
<p>Regenerative – Natural vegetation has been removed in the past, but is in the process of growing back towards a natural state.</p>

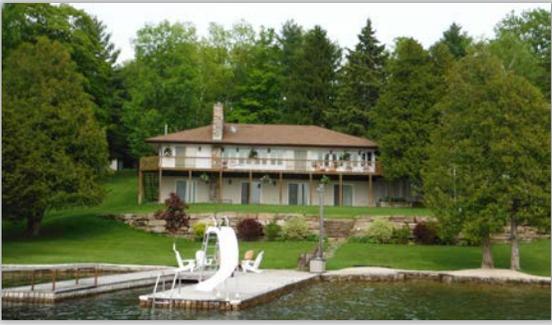
<p>Ornamental – All natural vegetation has been removed and replaced with mowed lawn and other non-native vegetation; structures such as docks, decks, boathouses and boat ramps are predominantly present at the shore.</p>

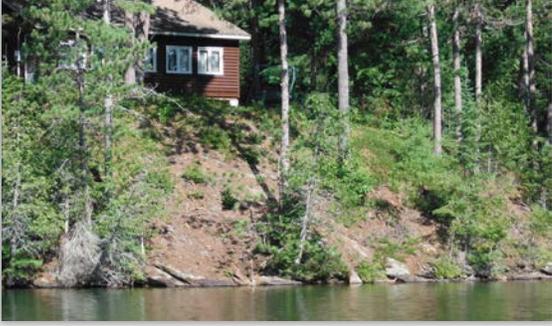
<p>Degraded – Natural vegetation has been lost; soil erosion, undercutting of the bank, and/or exposed roots of shrubs and trees are significant.</p>

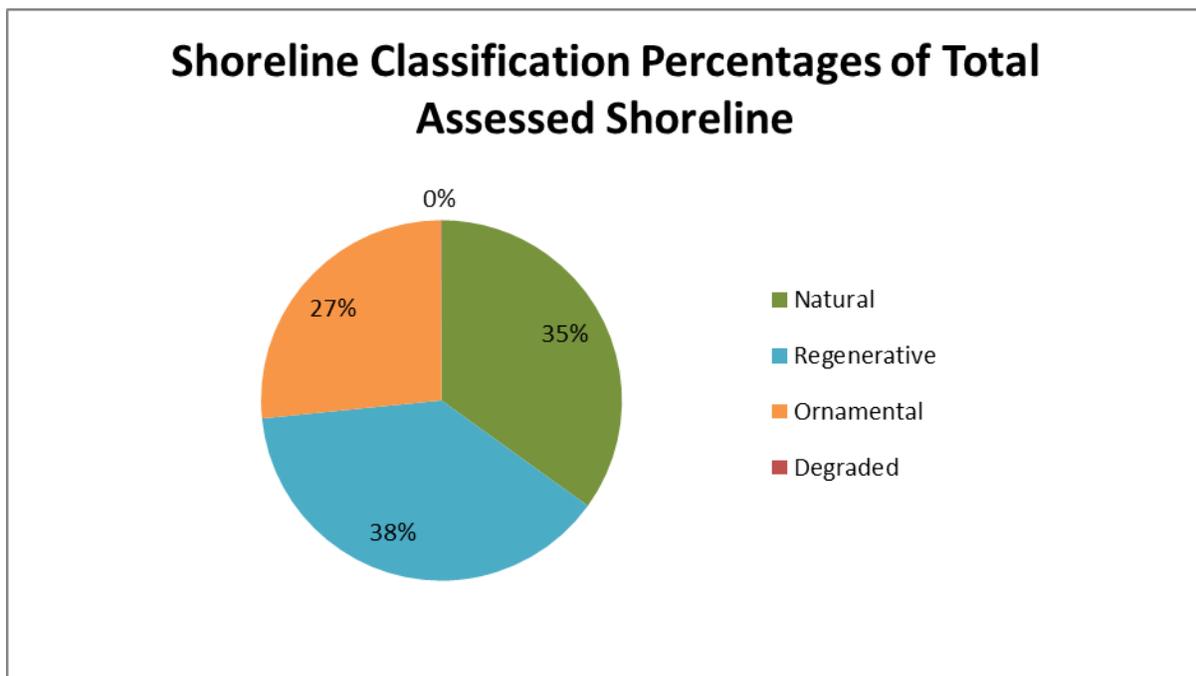
Figure 1. Total classification percentages of all assessed shoreline properties on Otty Lake.

- 13,470 meters or 35% natural;
- 14,894 meters or 39% regenerative;
- 10,243 meters or 27% ornamental; and,
- 25 meters or 0.1% degraded.

Figure 1 shows the percentage of the entire assessed shoreline in each classification. The overall estimated length and percentage of shoreline development on Otty Lake is 5,934 meters or 15%. The overall estimated length and percentage of retaining walls on Otty Lake is 2,639 meters or 7%. Table 2 summarizes these results.

On Otty Lake, the majority of the shoreline (39%) is classified as regenerative, followed by 35% being natural and 27% being ornamental. It is recommended that landowners engage in naturalization projects to further decrease the ornamental percentage and increase the regenerative and natural percentages.

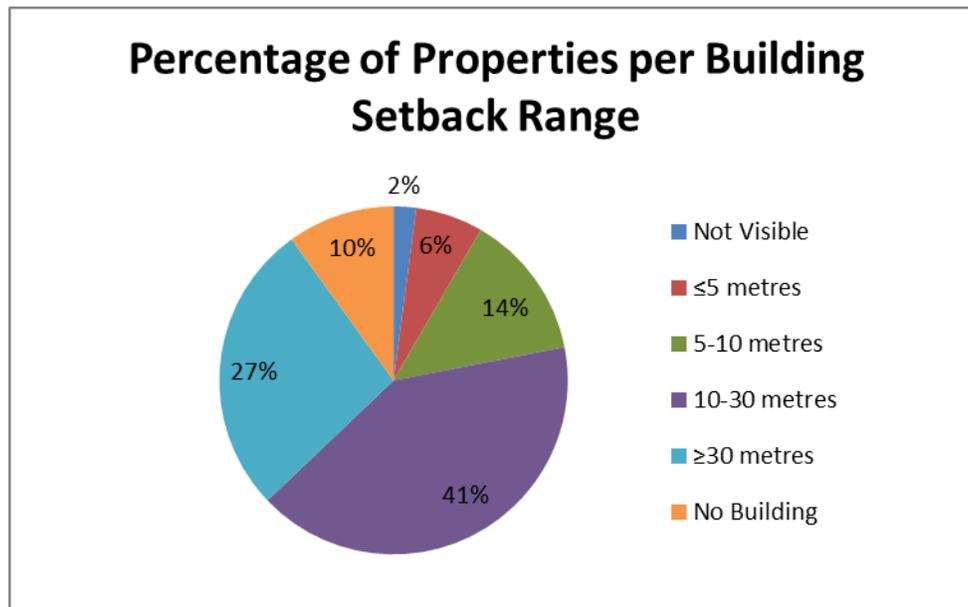
Figure 2. Main building setback ranges of all shoreline properties assessed on Otty Lake.

On Otty Lake, the number of properties with various building setback ranges were observed and recorded. As shown in Figure 2, the following numbers and percentages of properties assessed on Otty Lake had the following building setbacks:

- 10 properties or 2.1% of properties assessed had building setbacks that were not visible;
- 30 properties or 6.3% of properties assessed were less than or equal to five metres from the shoreline;

- 64 properties or 13.5% of properties assessed were between five and 10 metres from the shoreline;
- 196 properties or 41.4% of properties assessed were between 10 and 30 metres from the shoreline; and,
- 129 properties or 27.2% of properties assessed were greater than or equal to 30 metres from the shoreline.
- There were 45 properties or 9.5% of properties assessed on Otty Lake without a main building.

Building setbacks for new shoreline developments in Ontario should be at least 30 metres from the high water mark; however, older cottage buildings may have been constructed closer to the high water mark. On Otty Lake, over 60% of the properties assessed were observed to be closer than 30 metres to the shoreline. These tend to be cottages or cottages re-developed into homes originally built when cottage developments were permitted closer to the water's edge. The primary problem associated with near-shore building setbacks is the insufficient area to buffer or filter contaminated runoff and wastewater from the main dwelling. While moving these buildings further back from the shoreline is not a feasible nor realistic option, naturalizing the shorelines of these properties would help address this issue.

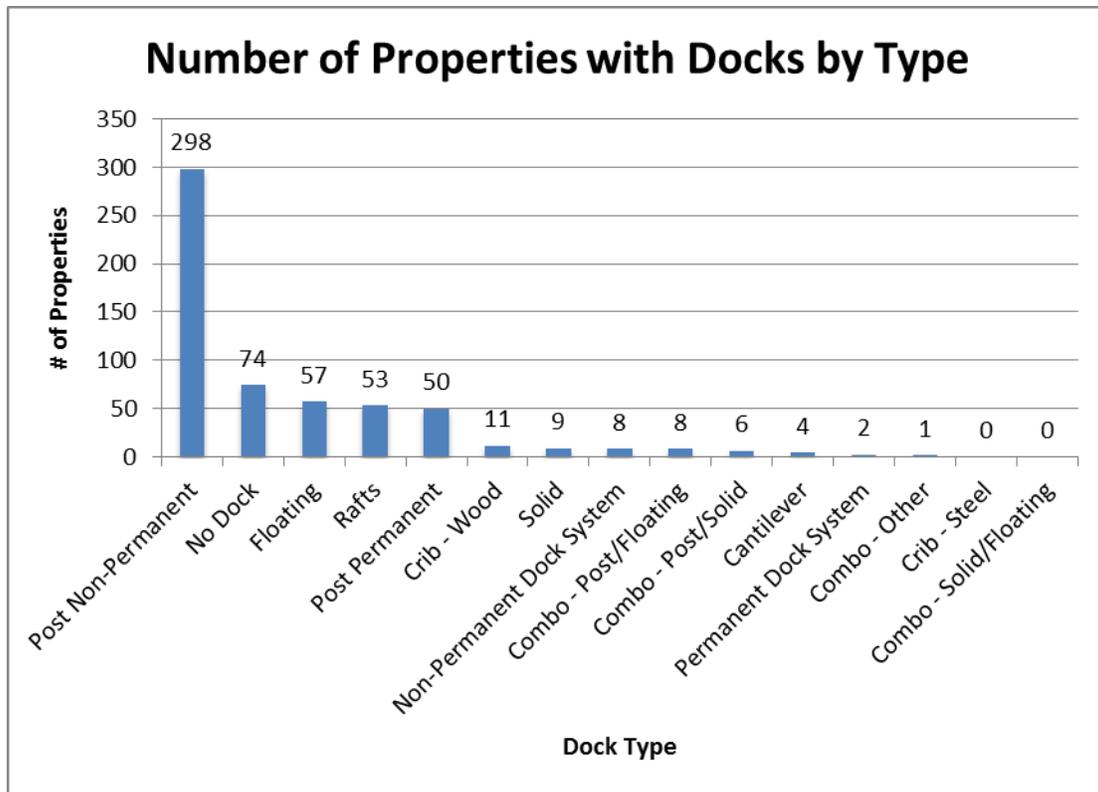
Figure 5. Types of docks of all shoreline properties assessed on Otty Lake.

- 6 properties or 1% of properties assessed had combo – post/solid docks;
 - 1 properties or 0.2% of properties assessed had combo – solid/floating docks;

- 0 properties or 0% of properties assessed had combo – other docks
 - 2 properties or 0.4% of properties assessed had permanent dock systems; and,
 - 8 properties or 1.7% of properties assessed had non-permanent dock systems.

Small floating or post docks are the best choice of docks as they have minimal contact with the lake bottom, and sit on or out of the water, which reduces the impact they have on the surrounding environment. In the future, if shoreline property owners need to replace their old or failing permanent post, solid, or crib docks, they could consider a non-permanent post dock or floating dock, thereby limiting impacts to fish habitat and ensuring the natural flow of water remains unrestricted.

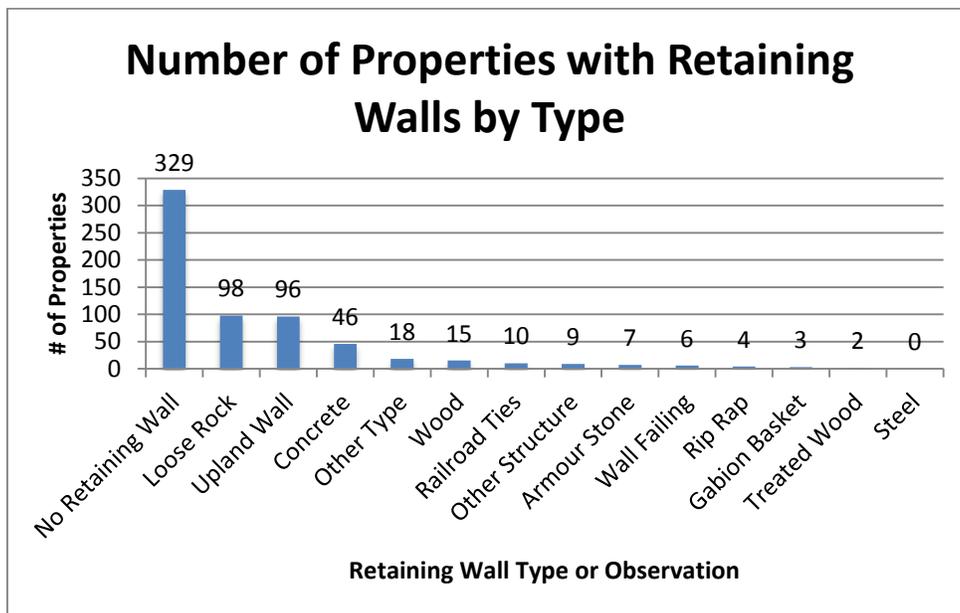
Figure 6. Retaining wall types and observations of all assessed properties on Otty Lake.

- 15 properties or 3% of properties assessed had wood retaining walls;
- 3 properties or 0.6% of properties assessed had gabion basket retaining walls;
- 7 properties or 2% of properties assessed had armour stone retaining walls;
- 46 properties or 10% of properties assessed had concrete retaining walls;
- 0 properties or 0% of properties assessed had steel retaining walls;
- 4 properties or 0.8% of properties assessed had riprap retaining walls;
- 98 properties or 21% of properties assessed had loose rock retaining walls;
- 18 properties or 4% of properties assessed had other types of retaining walls; and,
- 329 properties or 69% of properties assessed were without retaining walls.

As shown in Figure 6 as well, the following numbers and percentages of properties on Otty Lake had retaining walls with additional observations:

- 6 properties or 1.3% of properties assessed had a failing retaining wall;
- 15 properties or 3% of properties assessed had railroad ties used as a wood retaining wall;
- 2 properties or 0.4% of properties assessed had treated wood used as a wood retaining wall;
- 9 properties or 2% of properties assessed had another structure (deck/dock) acting as a retaining wall; and,
- 96 properties or 20% of properties assessed had an upland retaining wall not on the immediate shoreline.

Most properties on Otty Lake, 329 properties or 69% of properties assessed, do not have a retaining wall. Of the retaining walls that are present along properties on Otty Lake, the most common choice was loose rock (98 properties or 21% of properties assessed), followed by concrete (46 properties or 9.7% of properties assessed).

While retaining walls were a common choice in the past, we now know about their impact to the natural environment. Waves and wakes are reflected back from flat, hard surfaces with the same vigour as they strike the wall. This causes excess turbulence in the water, which scours the sediments from the lake bottom. Solid walls also eliminate shoreline habitat and act as a barrier, preventing local wildlife from reaching the water. Although some retaining walls (like rip rap) have fewer impacts than other retaining walls (like armour stone), shoreline property owners could consider alternative erosion control methods (like planting vegetated buffers or shoreline bioengineering) if they ever wish to replace their current, old, or failing retaining wall. In the meantime, maintaining vegetation around the wall and allowing new vegetation to establish and grow, will help reduce runoff and erosion.

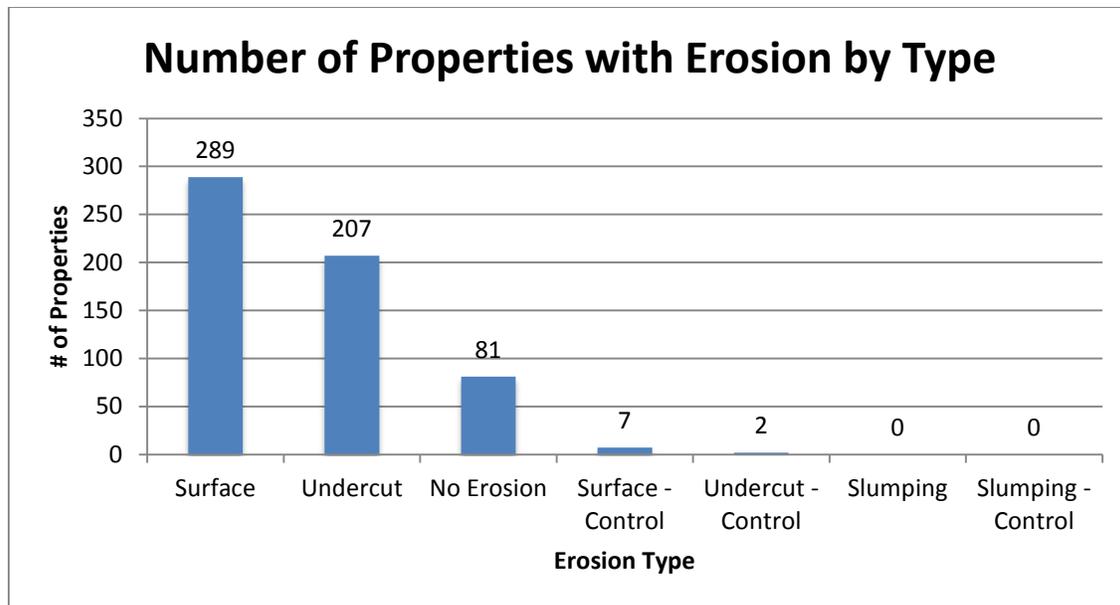
Figure 7. Erosion presence observed on shoreline properties assessed on Otty Lake.

As shown in Table 3, 393 properties or 82.9% of properties assessed on Otty Lake had some form of observable erosion (including surface, mass movement/slumping, or undercut bank); and, nine properties or 1.9% of properties assessed had significant erosion with recommended action. Each property can have more than one type of erosion. Figure 7 shows the percentage of each type of erosion present on assessed shoreline properties on Otty Lake.

Category	# Properties	% of Properties
Erosion presence		
Surface	289	61
Mass movement/slumping	0	0
Undercut bank	207	43.7
Erosion requiring action		
Surface	7	1.5
Mass movement/slumping	0	0
Undercut bank	2	0.4
No erosion	81	17.1

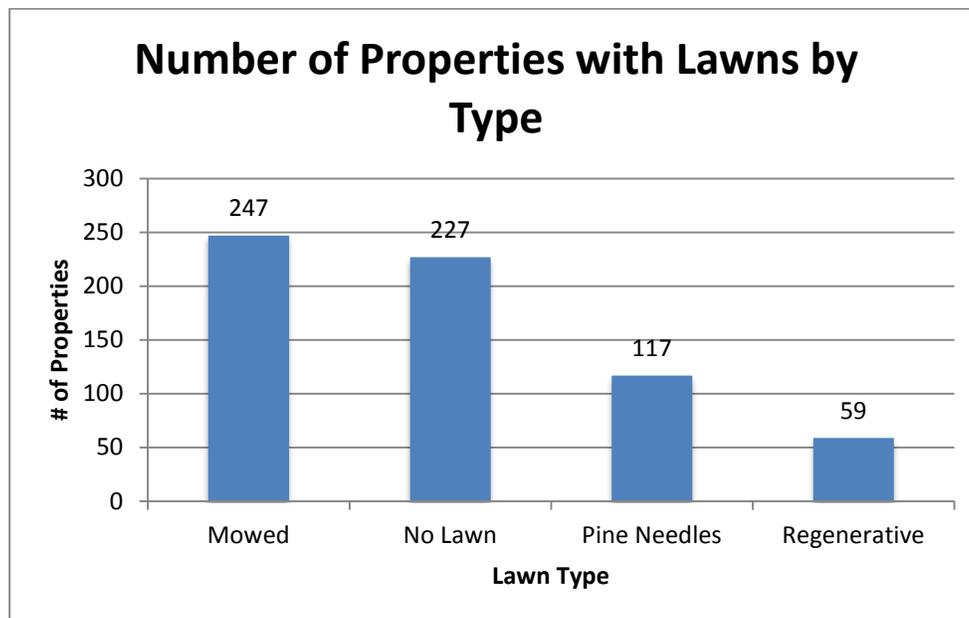
Figure 8. Presence of lawns observed on shoreline properties assessed on Otty Lake.

As shown in Figure 8, the following numbers and percentages of properties on Otty Lake had lawns, by lawn type:

- 247 properties or 52.1% of properties assessed had mowed lawns;
- 59 properties or 12.4% of properties assessed had regenerative lawns;
- 117 properties or 24.7% of properties assessed had pine needles; and,
- 227 properties or 47.9% of properties assessed had no lawn.

In areas close to the shoreline, a lawn is generally not a good choice of ground cover because over 55% of precipitation runs off mowed grass directly into the lake, instead of returning to the underground water cycle by filtering through the soil. On Otty Lake, 249 properties or 52% of properties assessed were observed to have a

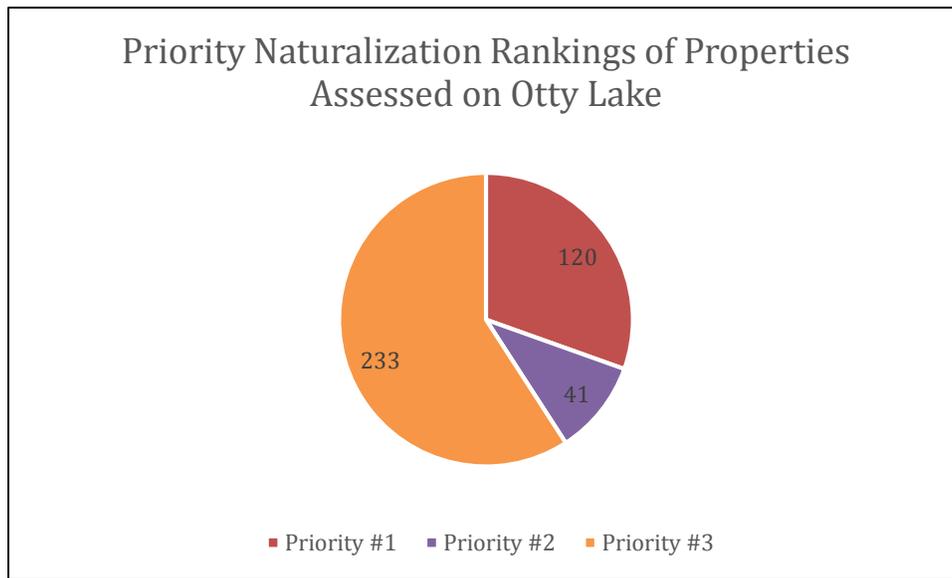
Figure 9. Priority Naturalization Ranking of Properties Assessed on Otty Lake.

Naturalization Priority	# Properties	% of Properties
Priority #1	120	25.3
Priority #2	41	8.6
Priority #3	233	49.2
